## AVIATION INVESTIGATION REPORT

A04P0047

### RISK OF COLLISION ON THE RUNWAY

NAV CANADA  
VANCOUVER TOWER  
VANCOUVER INTERNATIONAL AIRPORT,  
BRITISH COLUMBIA  
03 MARCH 2004

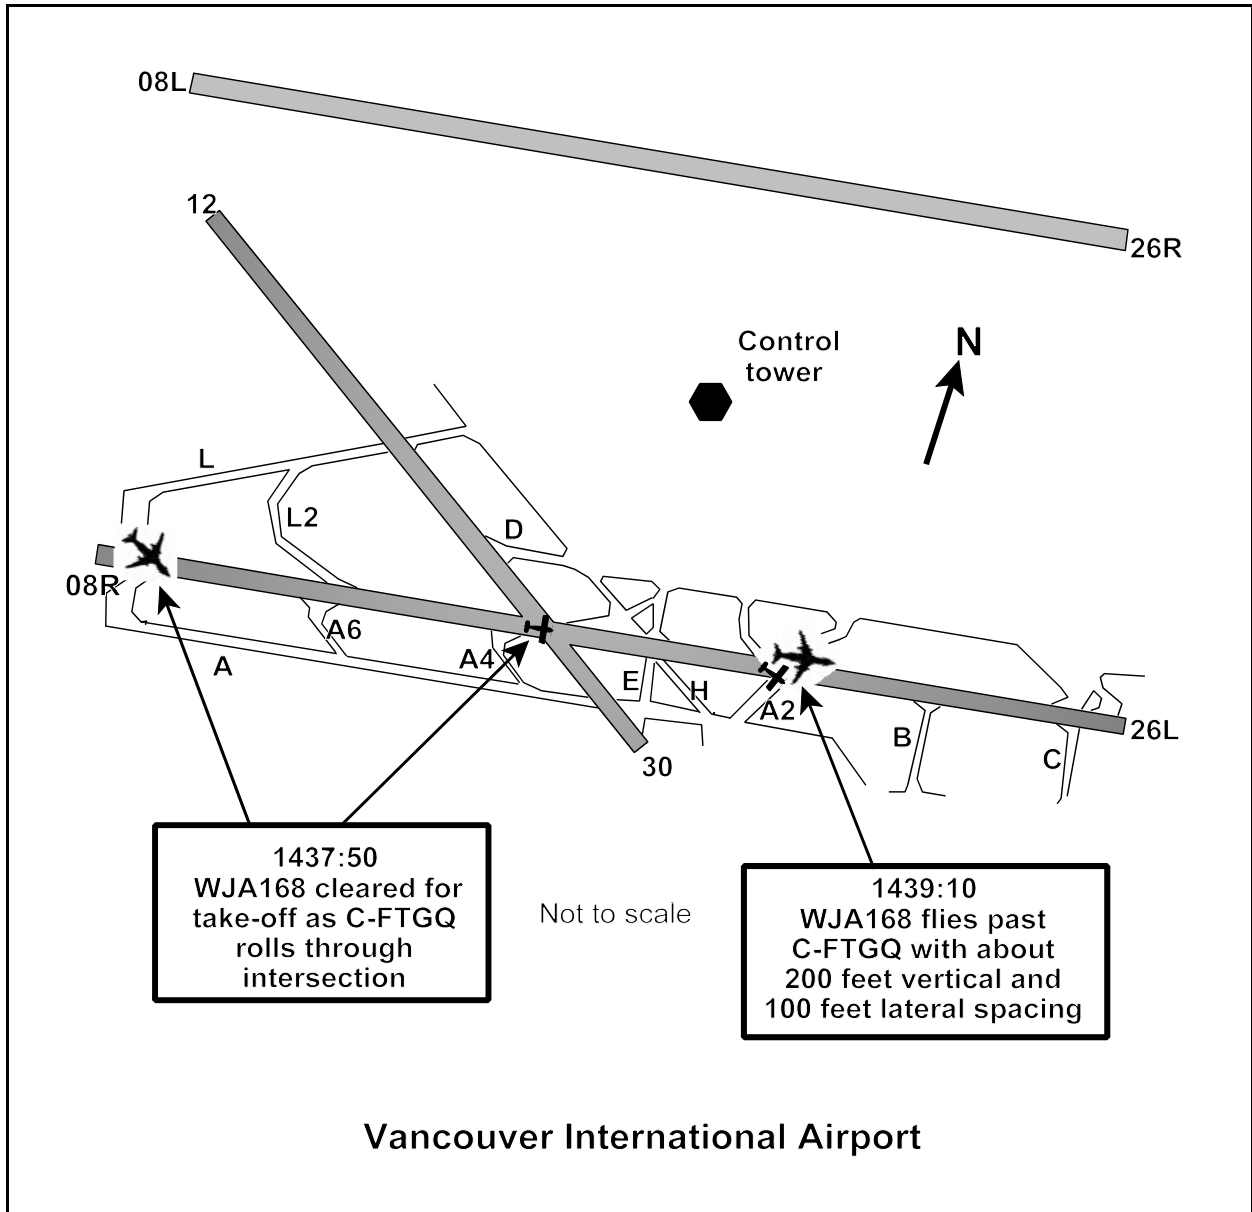
*Appendix A – Near Miss Between WJA168 and C-FTGQ*

After WJA168 had passed 80 knots on the take-off run, the pilot flying saw a light ahead near the side of the runway. He alerted the pilot not flying, and both pilots looked for the source of the light. On hearing the TS controller instruct an aircraft to expeditiously vacate the runway, the pilot flying saw the Cessna. Assessing the situation, he determined that there was sufficient room to continue the take-off and avoid the other aircraft, rather than abort the take-off at high speed thus risking a collision on the runway. WJA168 rotated at approximately 145 knots just beyond the intersection of Runway 12. A replay of the airport surface detection equipment (ASDE) radar showed that WJA168 passed approximately 100 feet to the left of the Cessna at an estimated height of approximately 200 feet. At the time, the Cessna was still on the runway at the entrance to Taxiway A2.
